INCIDENT INVESTIGATION #232178

1214Quincy st, Rapid City, SD

Event Type: Underground Damage

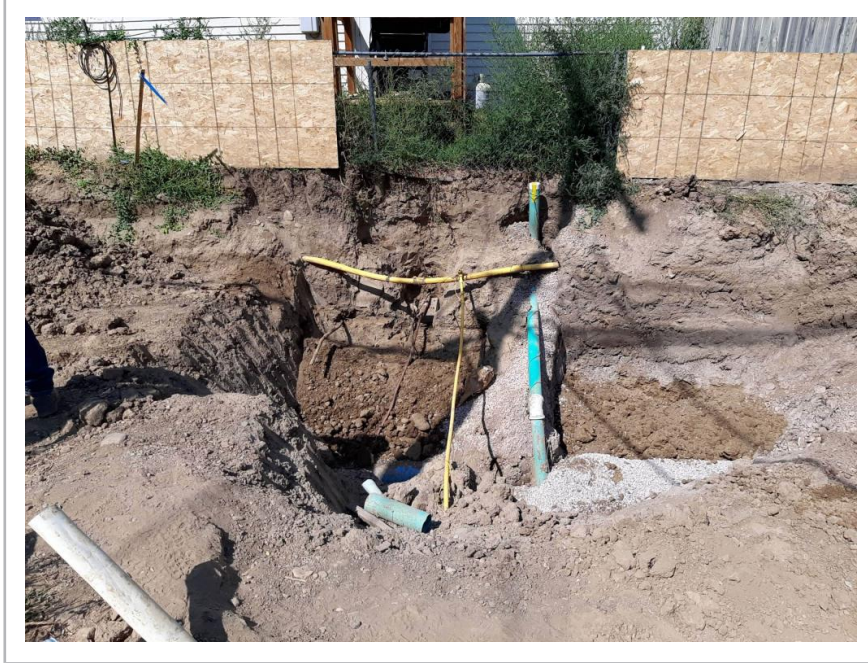
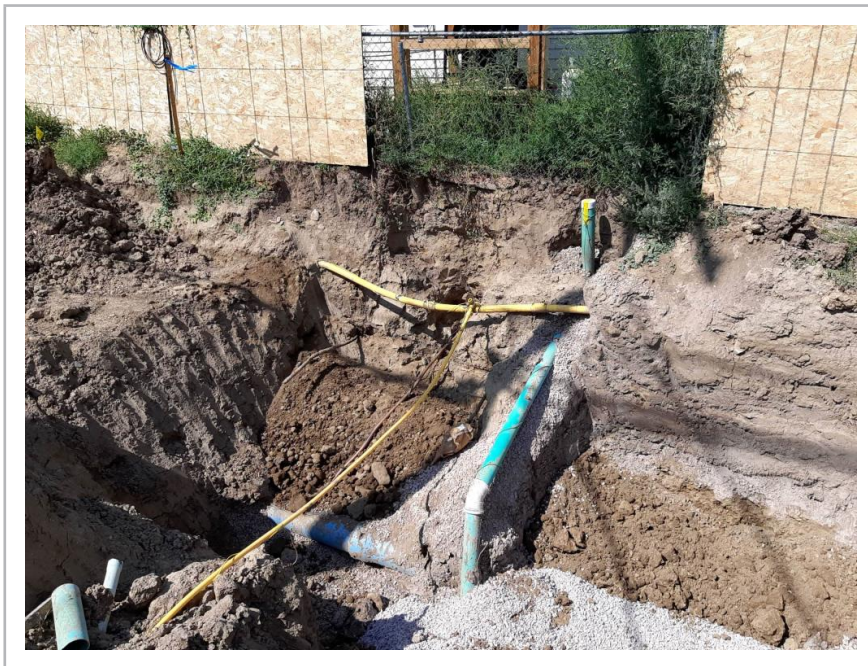
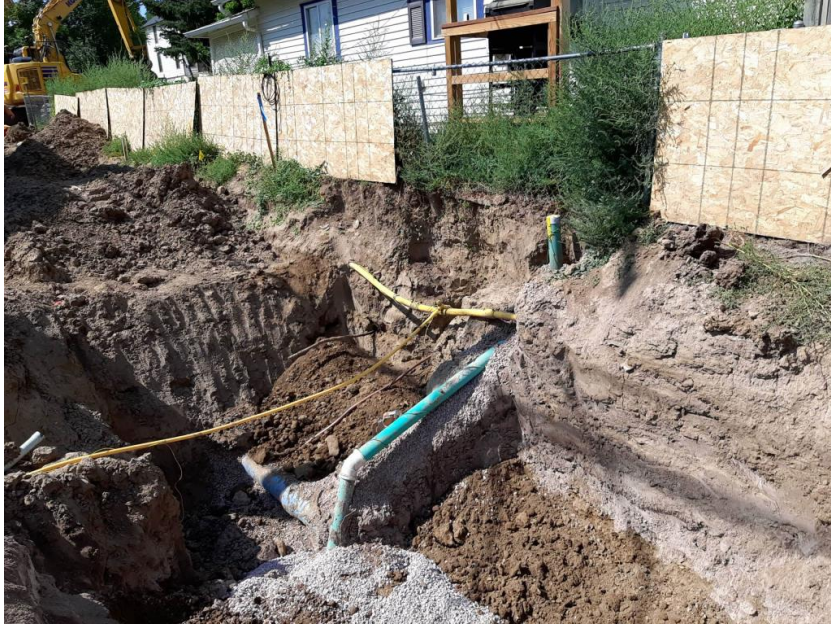
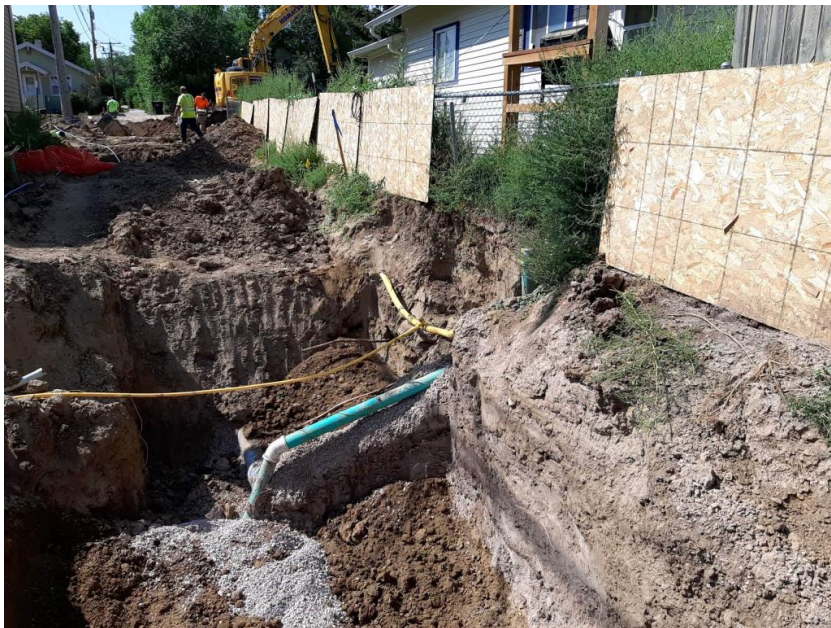
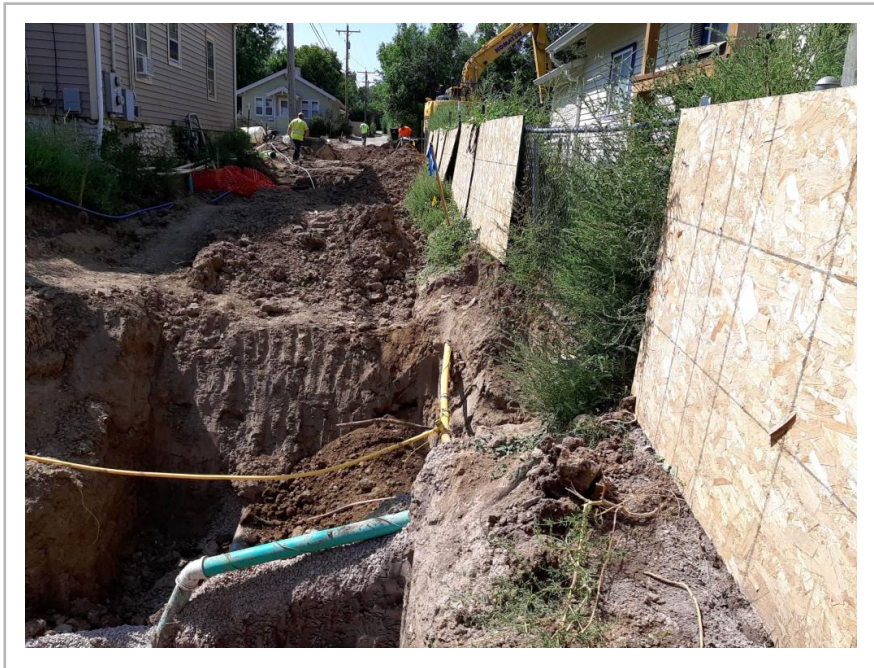
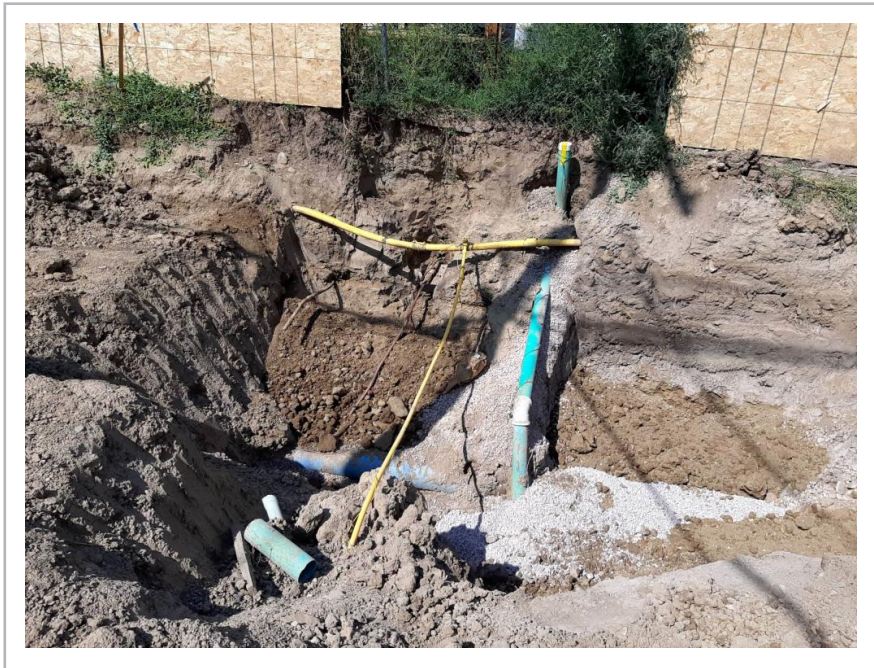
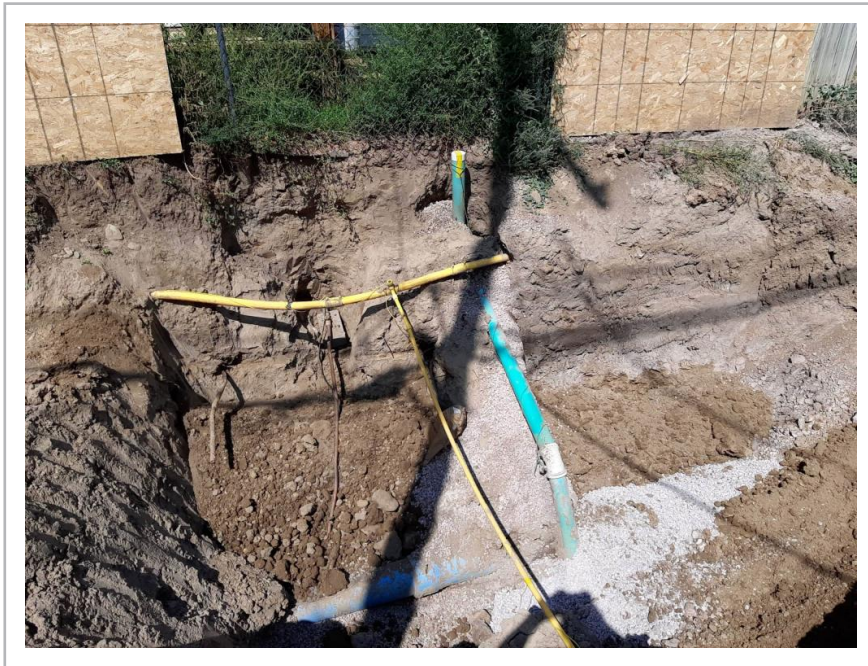
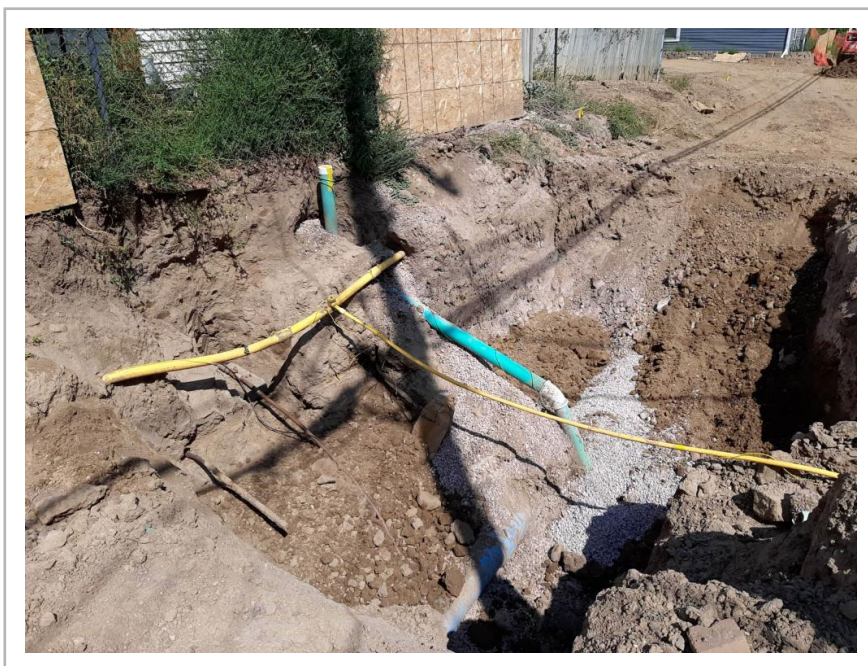
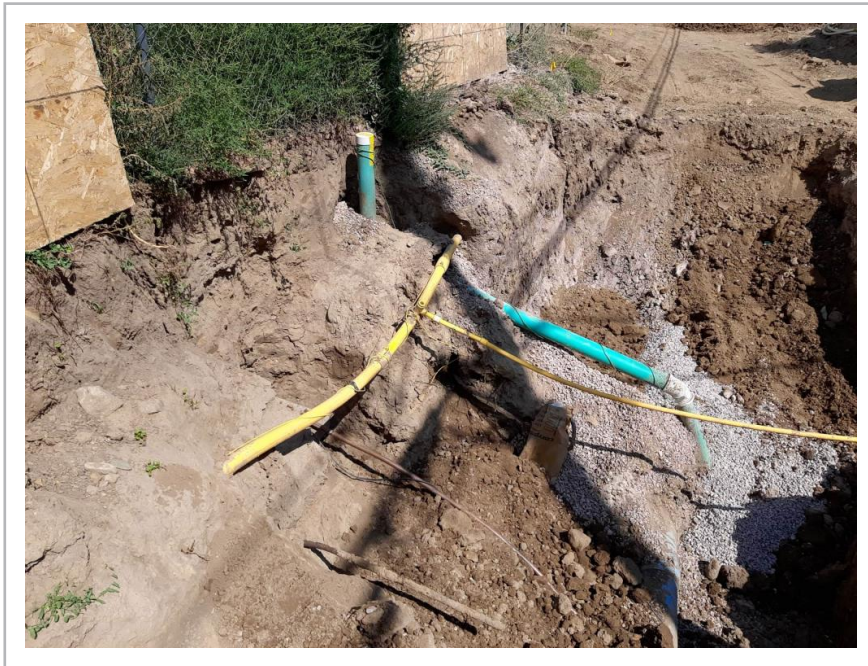
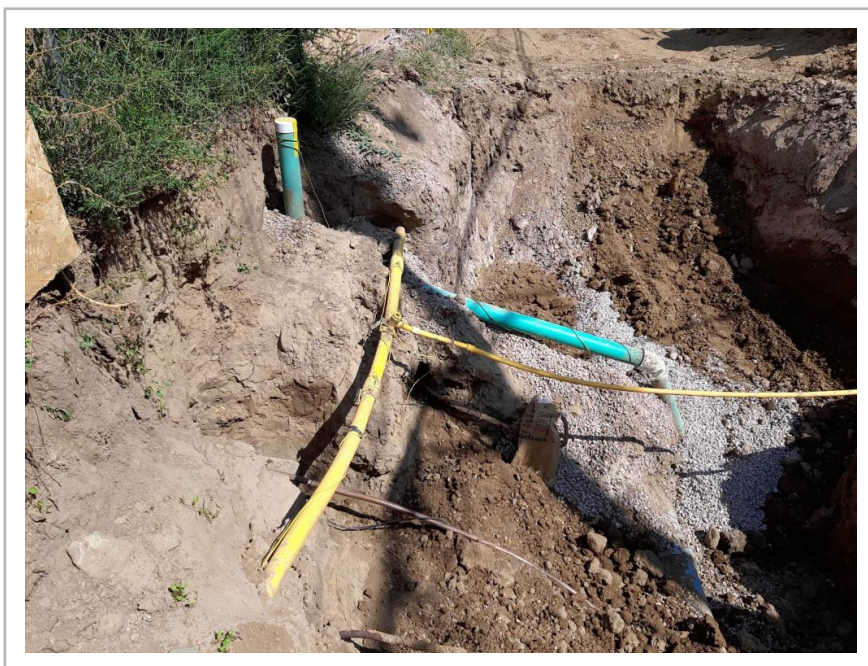
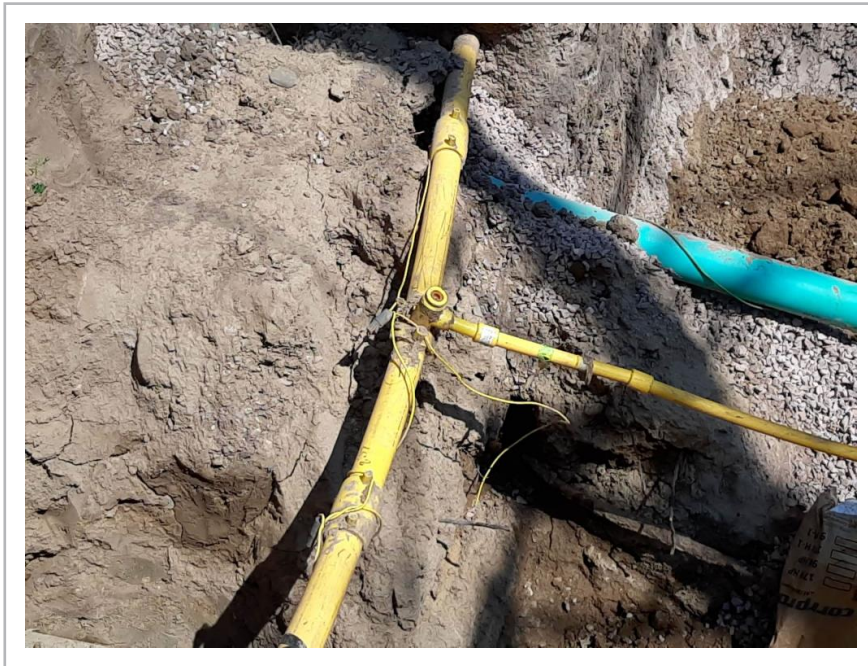
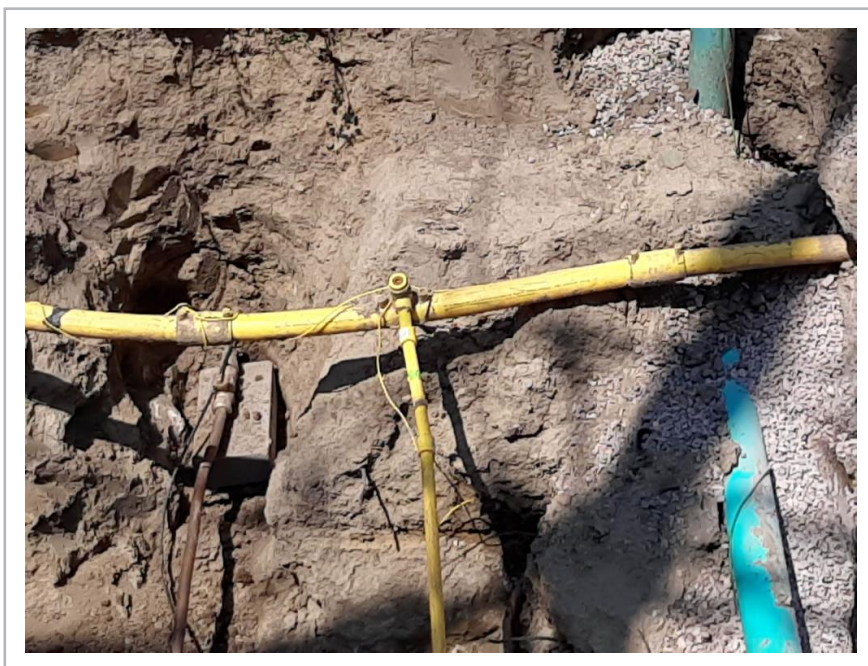
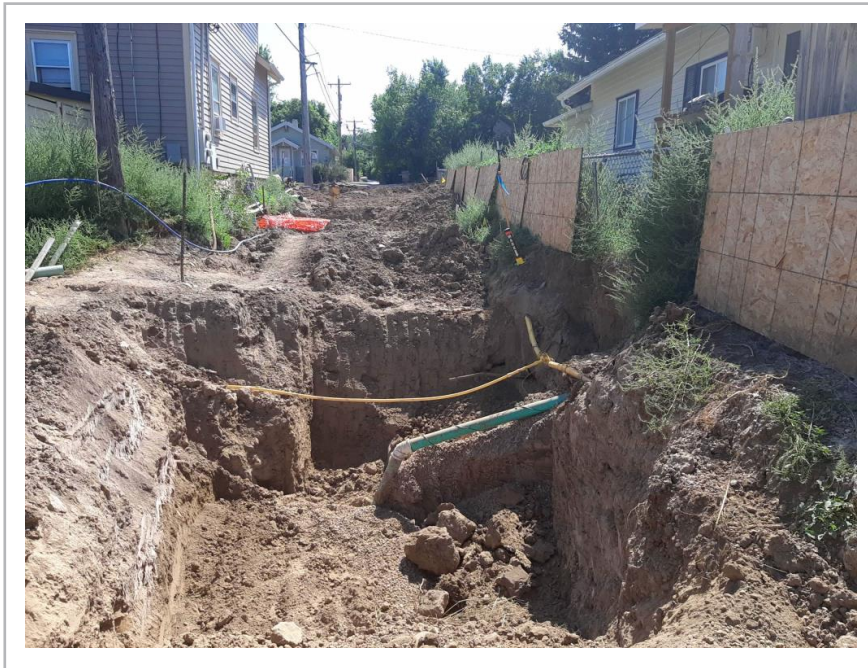
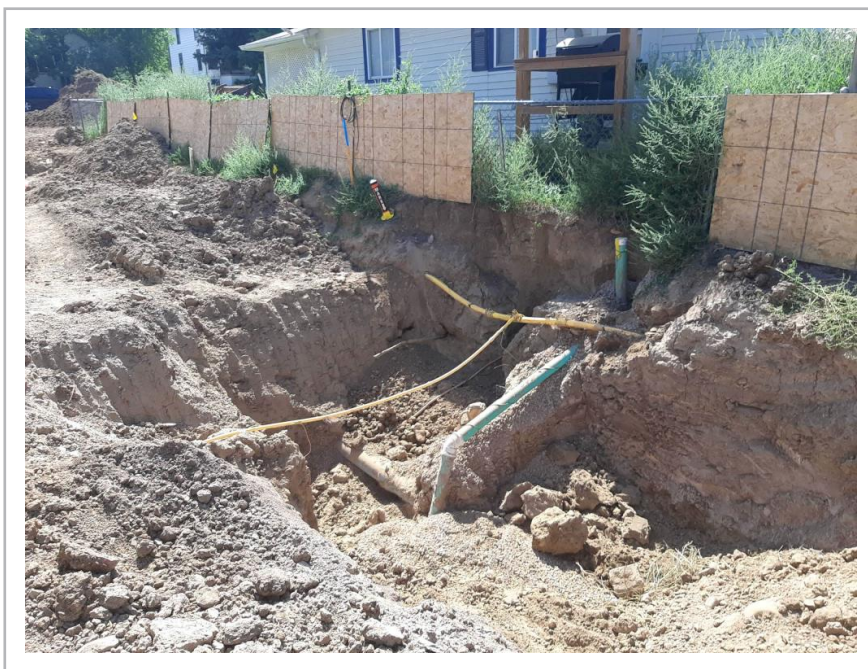
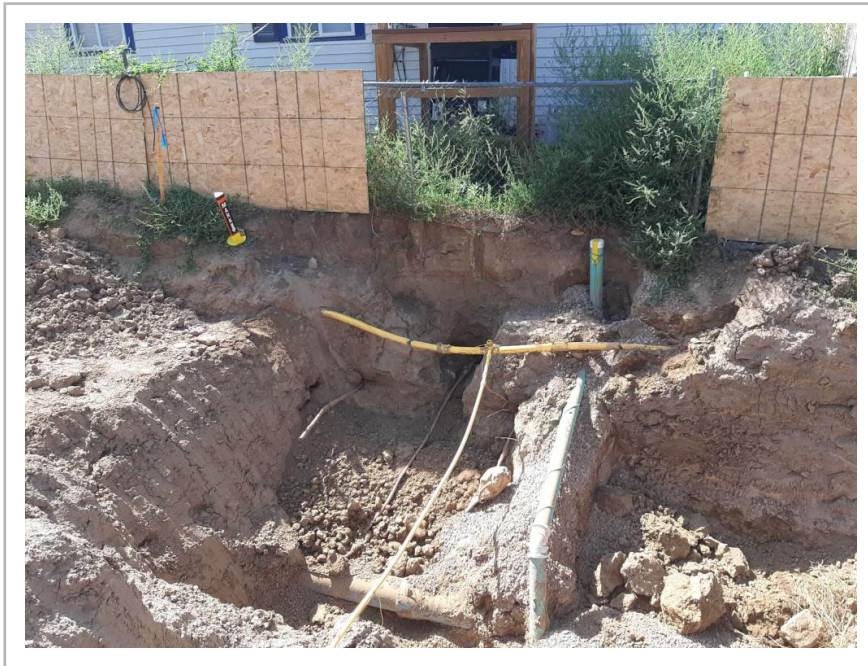
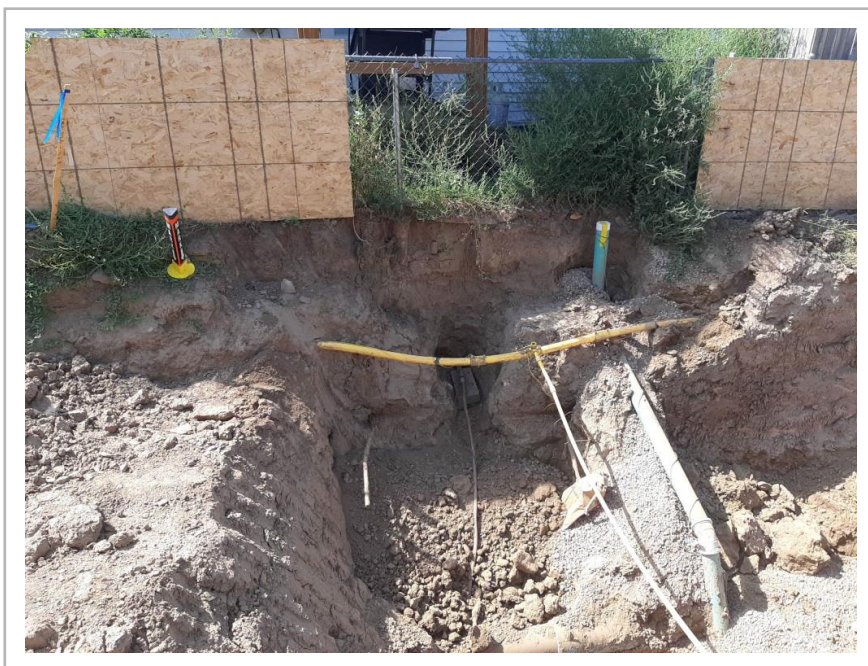
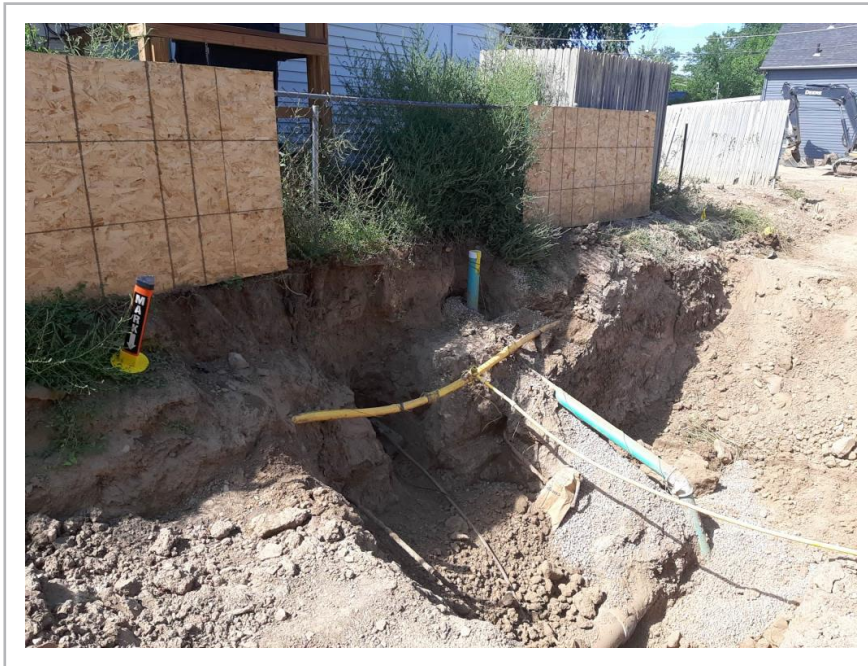
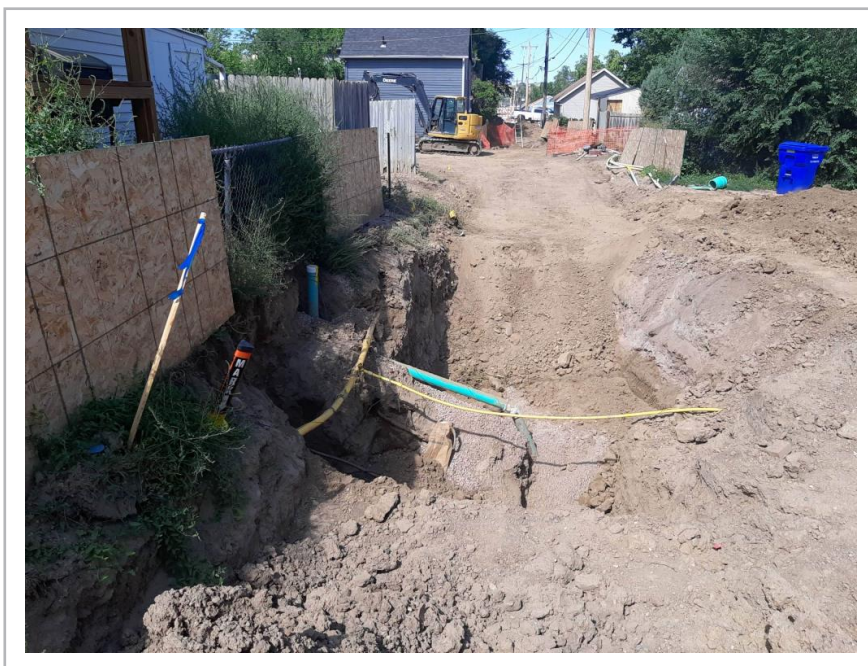
NEW INCIDENT PHOTOS

Assessment Comments: 2in plastic gas main was exposed and at some point contractor broke the sealing cap off the top of the T where the service comes off the main. This was discovered by MDU while at another damage ticket. This damage was not reported until MDU saw it on site. Unable to put out damage cones while taking investigation pictures dues to improper shoring by contractor.
